FINAL REPORT OF POWER INTERRUPTION
TO OAK RIDGE GASEOUS DIFFUSION PLANT
GENERATING STATION OF JANUARY 17, 1950

Date of Issue: May 14, 1959

Report No.: KP-1633

FINAL REPORT OF POWER INTERRUPTION
TO OAK RIDGE GASEOUS DIFFUSION PLANT
GENERATING STATION OF JANUARY 17, 1959

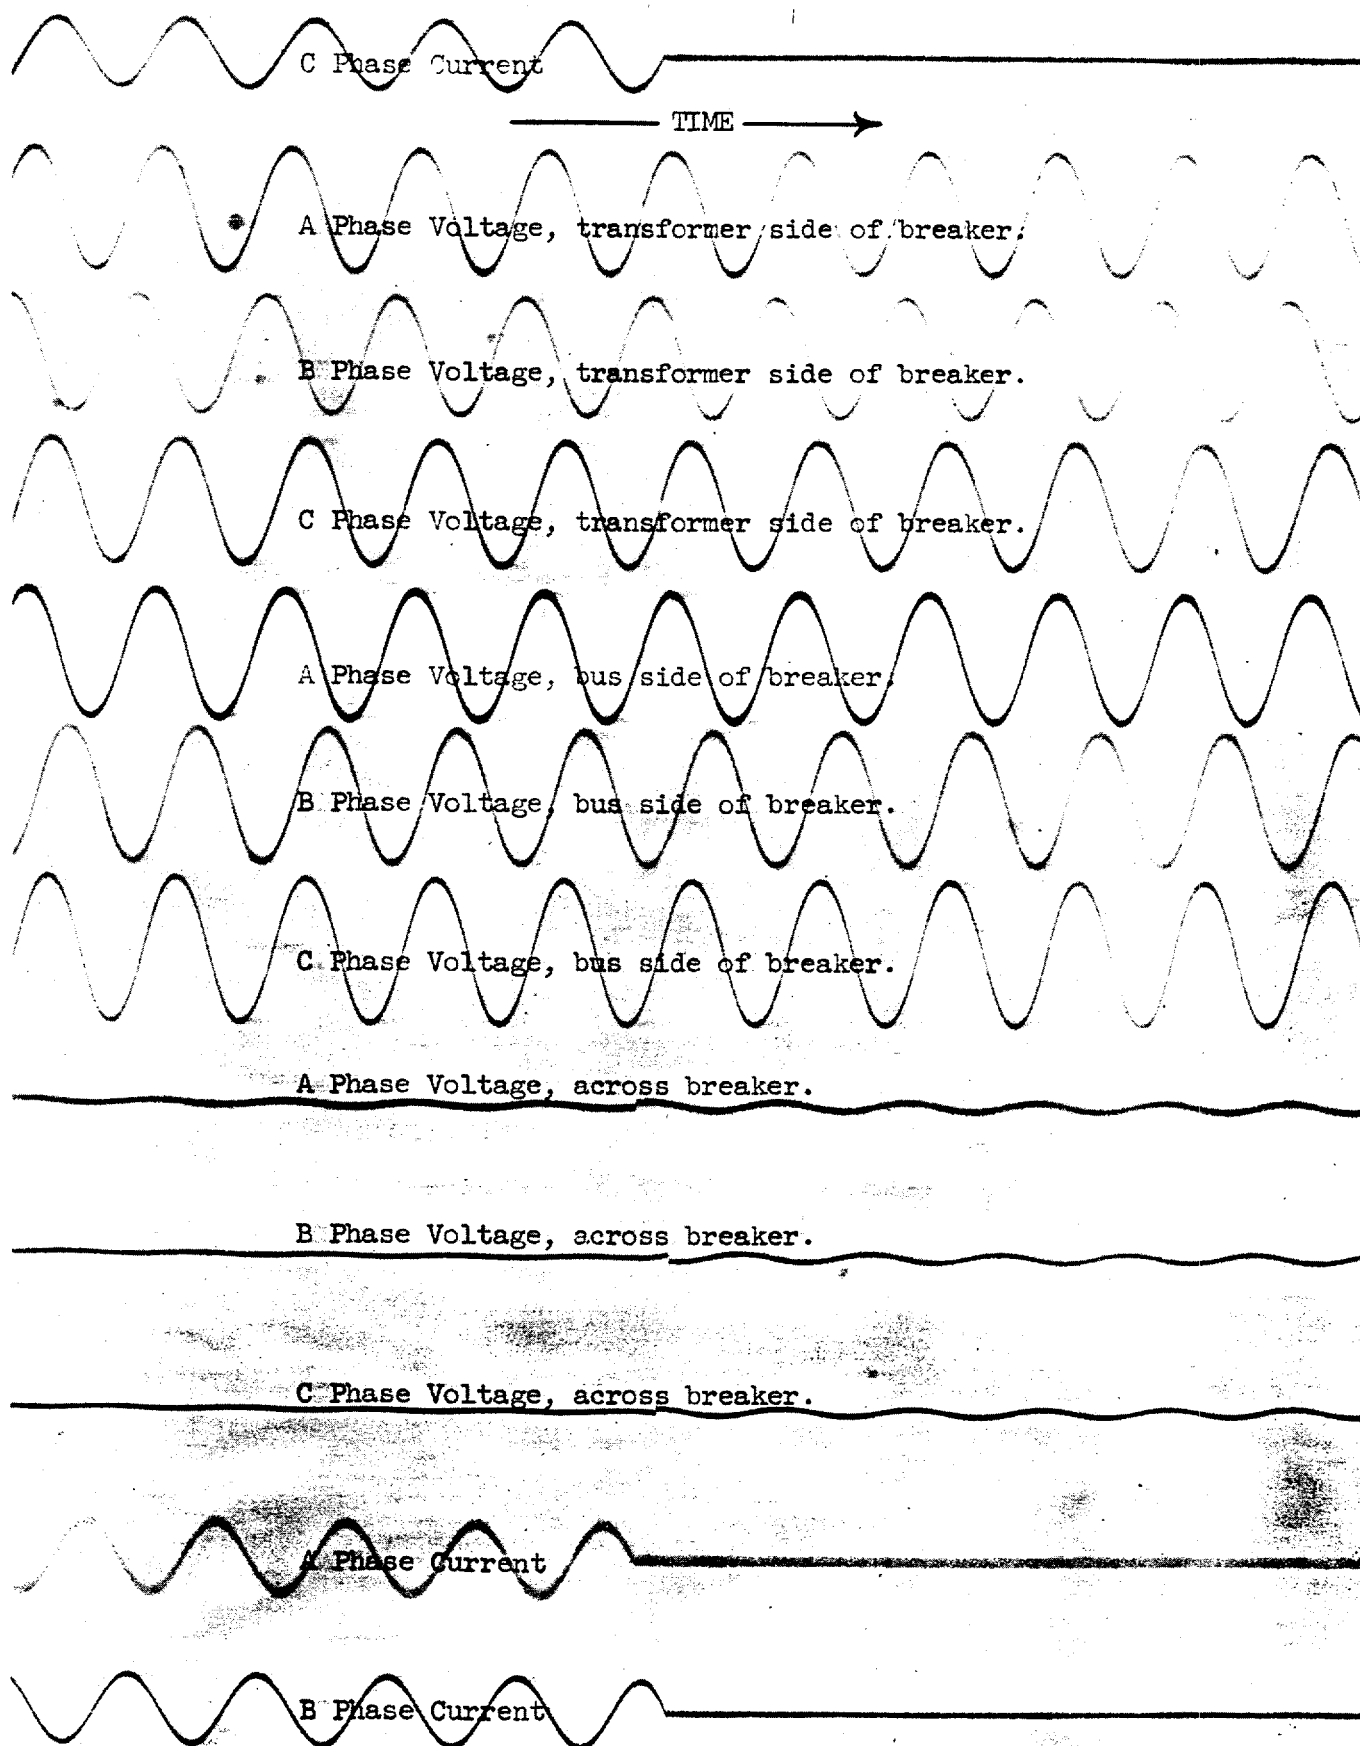
Four failures have been experienced in K-31 on air circuit breakers of the same General type as the 13.8-kv breakers which failed on January 17. These K-31 breakers are new models of the original Westinghouse CA breakers installed in the K-25 and K-27 switchhouses. The first failure occurred in 1954, two occurred in 1956, and the last one occurred in 1958. All of the failed breakers were power transformer secondary breakers and the failures occurred on normal opening cycles when the breakers were carrying a current slightly less than half

of the continuous full load rating of the breaker. Discussions with the manufacturer were instigated following the first failure in 1954 and further investigation following the 1958 failure was in progress to try to determine the cause or causes for these faults when the subject failure occurred on January 17. It was the feeling of the committee that there may have been a correlation between the trouble experienced on breaker 53-E and the failed ACBs at K-31. Due to an improvement in the relaying scheme at K-31 before the last failure there, the breaker sustained only minor damage, and the committee hoped that by a vigorous pursuit of the investigation of this last K-31 failure, the cause of the failure of ACB 53-E might well be found. This failure at K-31 had definitely been a ground fault through air from the movable contact on the center phase to the cubicle door. When several members of the committee met with Westinghouse personnel at East Pittsburgh, Pennsylvania on February 3, 1959, considerable time was spent in a discussion of these K-31 failures. The Westinghouse personnel were of the definite opinion that the K-31 failures were due to some unknown circuit condition, and had no relation to the failure of ACB 53-E. They requested that a number of oscillograms be made during the same type of normal opening cycles on which the failures had previously occurred. They suggested that the line-to-ground voltages on each side of the test breaker, as well as the voltage across the breaker and the line currents through the breaker, be recorded on oscillograms during the opening operations. Because of the possibility that high frequency voltage waves might not pass through the potential transformers and appear on the oscillograms, resistance voltage dividers were used to insure the fidelity of the results. Oscillograph galvanometers with good high-frequency response were also used to make certain reliable information was obtained. Forty-one oscillograms were made, with thirty-nine being made on opening cycles and two being made on closing cycles. The tests made on opening cycles were made under three different conditions of loading and all tests were performed on ACB 405, which was the last breaker at K-31 to fail. This breaker had required only the filing down of the contact parts where the arcing had taken place and the revarnishing of a burned spot on the blast tube following the failure, and since neither UCNC nor Westinghouse maintenance personnel could find any maladjustment or defect in the breaker, it was thought that this breaker, which was in the identical condition prior to its failure, would be a good test specimen. System conditions were likewise identical to those existing at the time of the last failure. No precautions were made to prevent a recurrence of the last failure, but none occurred, although enough tests were made to equal the number of normal operations of all transformer secondary breaker operations at K-31 over a two-year period, which has been the failure frequency rate. One of the oscillograms obtained from these tests is shown in Figure One and it is typical of the others. No abnormal conditions were found to exist, according to the evaluation of local personnel, but all of the oscillograms have been sent to Westinghouse for their study and comments.

Typical oscillogram showing voltage-to-ground on each side of K-31 ACB 405, Voltages Across the Breaker, and Line Currents Through the Breaker, during a normal opening cycle, made on March 24, 1959.

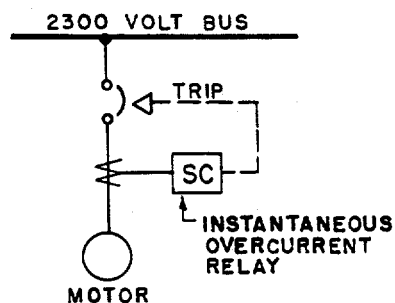
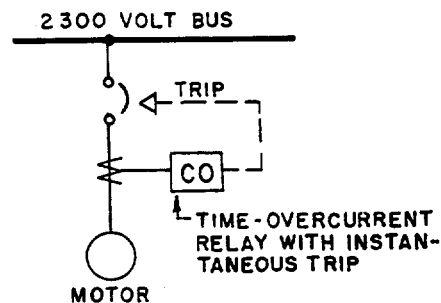
SCHEMATIC DIAGRAMS OF RELAYING IMPROVEMENTS A. RELAY PROTECTION FOR POWERHOUSE 2300 VOLT MOTORS

At the present time the only relay protection installed on the 2300-volt circuits which feed from the three auxiliary 2300-volt buses at the powerhouse is instantaneous overcurrent tripping. These relays must be set at approximately nine times the full load current on the motor circuits, to prevent undesirable trip-outs on start-up. Consequently, any fault must develop into a major failure before these relays will actuate to trip the breaker. The motors to powerhouse auxiliaries, such as boiler feed pumps, induced- and forced-draft fans, generator exciters, circulating water pumps, etc., are normally protected by time-overcurrent relays in addition to instantaneous overcurrent relays, as shown in Part A of Figure Two. The eighty-eight circuits at the powerhouse which need such protection could be equipped with these time-overcurrent relays for \$35,030. The 2300-volt motors which power the air compressors and recirculating water pumps in the K-1101, K-802, and K-832 buildings need the same improvement in relay protection. This will cost an additional \$15,750.

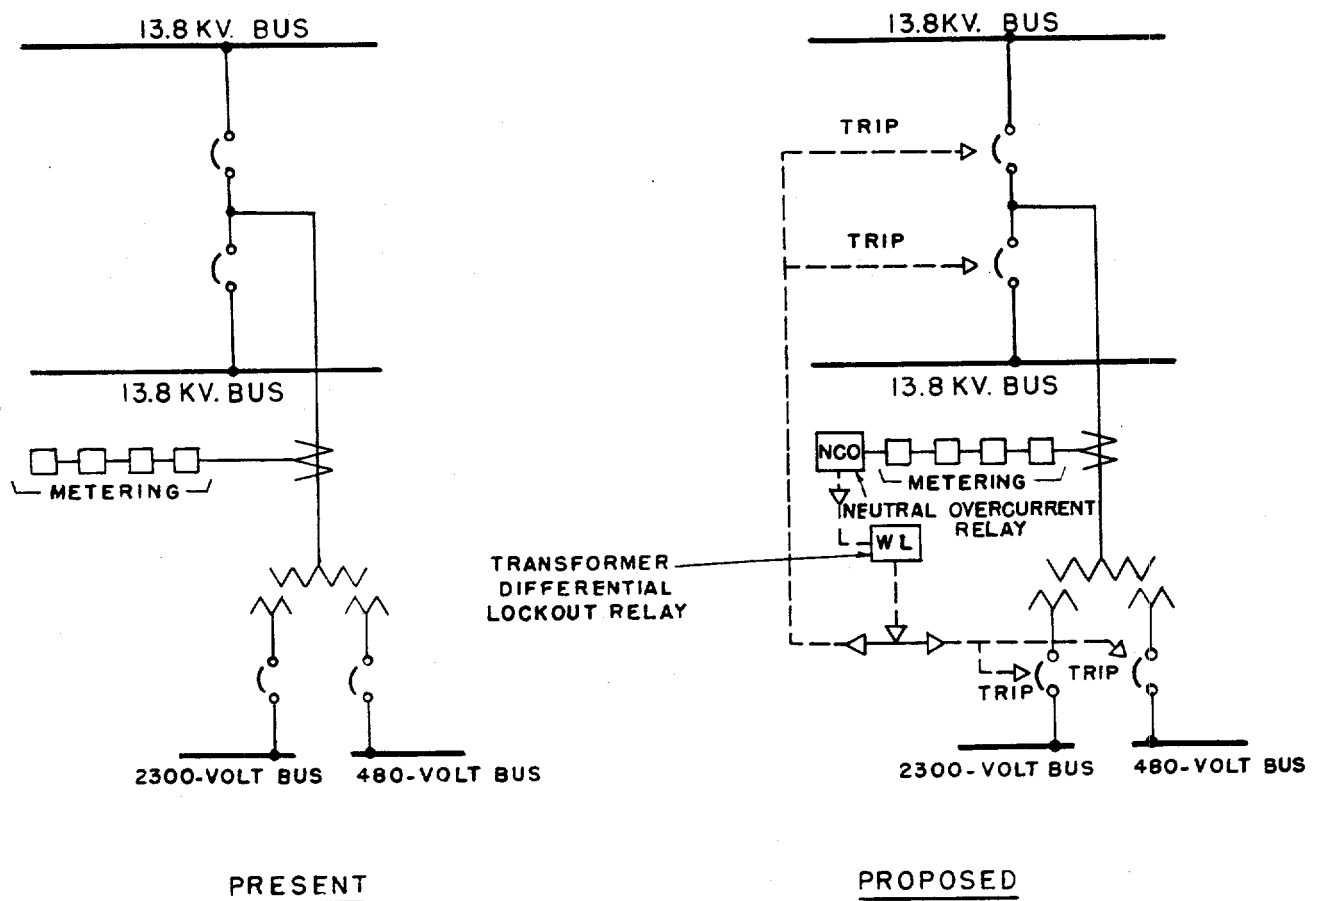
E. GROUND RELAYS FOR HIGH-VOLTAGE WINDINGS OF THE AUXILIARY TRANSFORMERS

The auxiliary transformers are presently protected by differential relaying, which is considered good protection, but it is somewhat insensitive at high loads. Sensitive ground relaying can be installed for approximately \$1,350 by the installation of residual relays, and this would greatly reduce any damage due to faults on the high side of the transformers. This is the same type of relaying that is installed on all of the feeders from the K-25 Switchhouse and it has proven to be highly satisfactory in the past. This relaying improvement is shown in Part E of Figure Three.

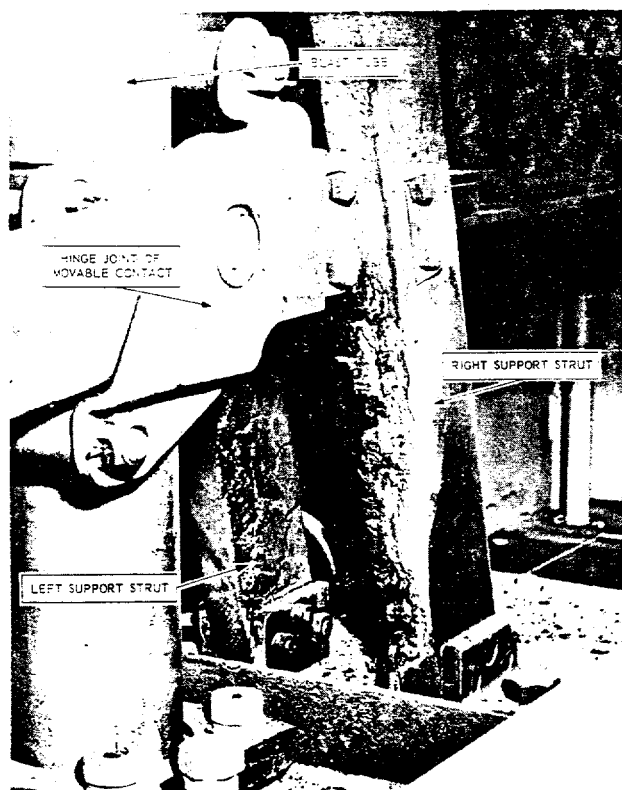
the surface from one end to the other. Approximately half of the blast tube support struts had some surface tracking, apparently caused by corona, and about one-third of the blast tubes had a small amount of corona tracking on the outside surfaces, principally near the grounded end of the blast tubes. An extreme example of deteriorated surface insulation on struts is shown in Photograph One. The two sides of the left strut shown in Photograph One are shown in Photographs Two and Three. Photograph Three shows how the destruction of the insulation progresses after leakage paths like those in Photograph Two have been established. It should be pointed out, however, that it is reasonably certain that most of this surface breakdown developed after the fault in ACB 53-E occurred. The fires in ACBs 53-E and 54-E produced voluminous quantities of thick black smoke which settled on all surfaces in the gallery, including the solid insulating parts inside the breaker cubicles. When the fires were still being fought, some of the breakers were energized from one side and arcing inside the breakers was noted. ACB 50-E, shown in Photograph One, was one of these breakers. If a breaker were energized with the Micarta insulation parts heavily coated with a carbonaceous dust, severe and wide-spread tracking could be expected to develop. Although it is undoubtedly true that most of the observed insulation deterioration happened after ACB 53-E failed, these cases clearly point out how fast and completely insulation can fail if the surfaces become contaminated with conducting materials, and emphasizes a cardinal point in maintenance of electrical insulation to "keep it clean". Three cases of corona tracking were discovered on arc chutes, and they are shown on Photographs Four, Five, and Six.

Photograph One
 PHOTOGRAPH SHOWING DAMAGE TO BLAST TUBE
 SUPPORT STRUTS ON ACB 50E, MIDDLE PHASE.

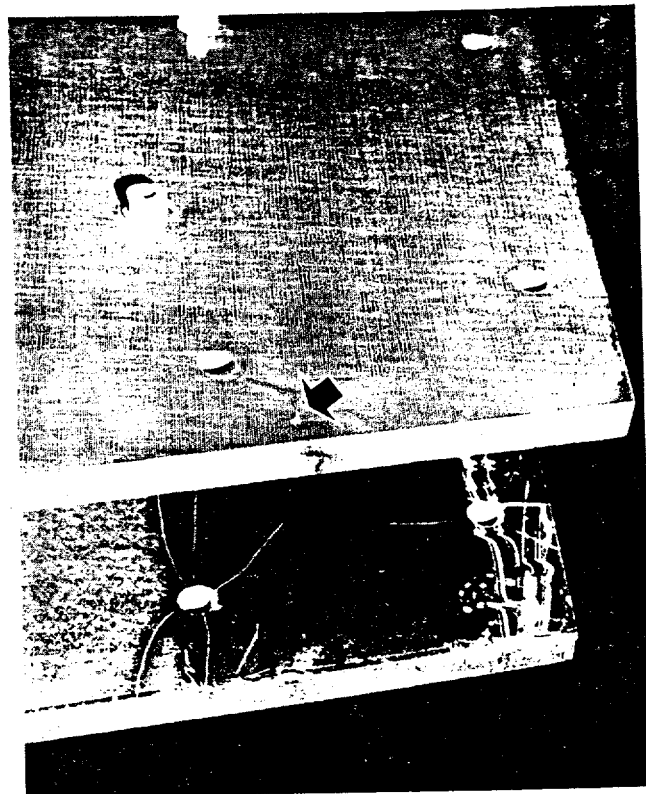
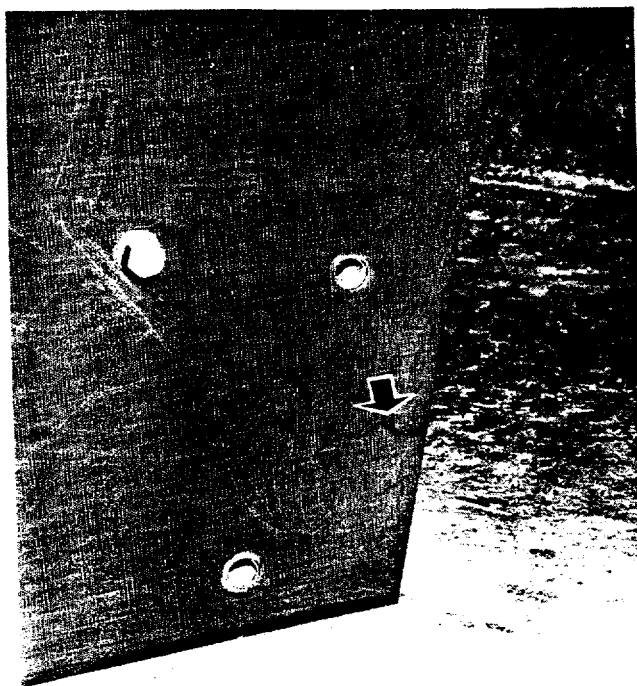
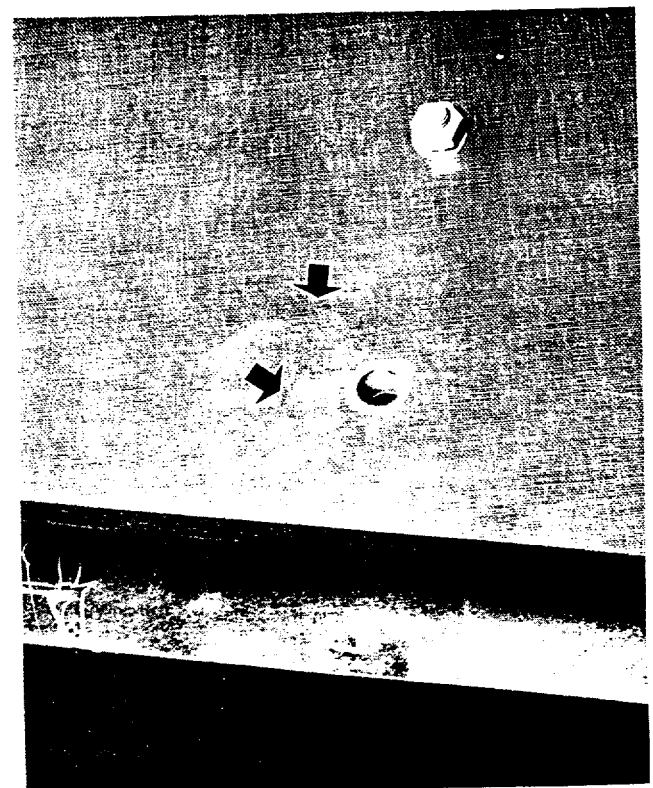
PHOTOGRAPHS SHOWING TRACKING ON SURFACES OF
ARC SHOTS CAUSED BY CORONA

All of the breakers on 60-E2 bus are to be overhauled in the near future in the same manner as was followed for the breakers on 60-E1 bus. It is believed that the condition of the insulation in the breakers on 60-E2 bus is typical of the condition which was present on the breakers on 60-E1 bus before the January 17 failure. Any insulation deterioration which exists in the breakers on 60-E2 bus will be found during the sanding of the Micarta parts prior to revarnishing. 37.5-kv a-c high potential tests, 40-kv d-c high potential tests, and Doble power factor tests will be made before and after the overhaul of these breakers and the results compared with the findings of the condition of the insulation during the reworking of the breakers. It is hoped that at least one of these three insulation tests will be proven to be effective in accurately measuring insulation damage, and predicting when insulation breakdown is imminent so that corrective measures can be made prior to the initiation of faults. From all the information the committee has been able to obtain, it is apparent that very little work has been done in this field, and only one company was found which periodically makes insulation tests on air circuit breakers.
